S/1 NEWS

S/1 NEWS is published monthly by R. Sullivan, WØYVA/4, POB 6216, Arlington, Virginia, 22206. Subscription rate is \$4.00 per year. Back issues 1-6 are available for \$2.50 ppd. Foreign by Air is \$9.25 per year.

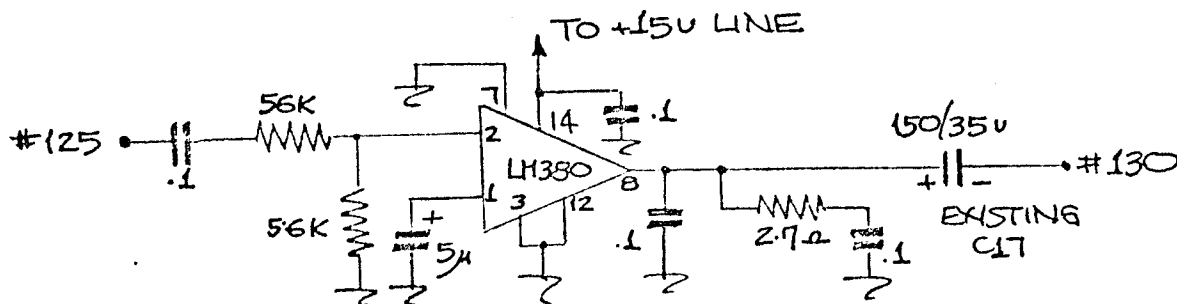
Wiring for the LM380 is as follows:

The following modification sent by WØNVE will provide for a much simpler audio output circuit and cleaner output. The parts count goes way down on the power supply board. The modification replaces the existing PA237 (or MFC9020) with a LM380 IC audio amplifier chip. The LM380 may be mounted on a small vector board or directly on the power supply board with some simple modifications. The following parts may be removed from the power supply board:

Notice that C17 may be reused but with reversed polarity. The output transformer is no longer used. Wire pin #130 from the power supply board directly to the speaker jack.

- C14, C15, C16, C20, C21, C19
- R34, R35, R36, R33, R37, R38, R42
- PA-237
- Q11, Q10, R22, R30, C18 (24-volt regulator parts)

If your unit utilizes the Motorola MFC-9020 audio output IC, refer to page 6-15, Figure 6.4A of the Thomas manual for parts to remove in lieu of those listed above. The 24-volt regulator parts listed above should be removed.

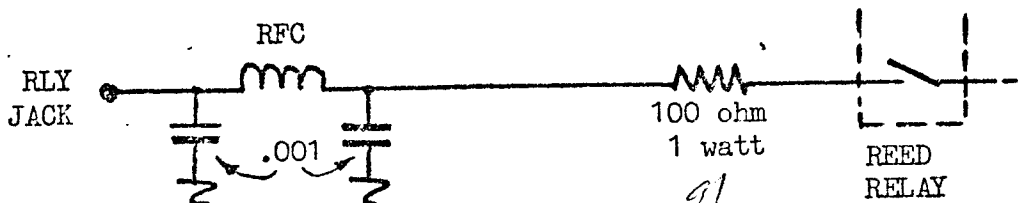
Another problem sometimes encountered when using the CX7 and A70 or A77 combination is CX7 control relay sticking. The symptom of this problem is the failure of the A70/77 to return to the receive condition when the CX7 does. The combination of vacuum T/R relay control for speed and rf bypassing in the A70/77 combine to provide a fairly substantial capacitive discharge through the relay control line upon closure. This is bad-news for reed relay contacts! The solution is simple and will provide protection for the CX7 control contacts. **MAKE THIS CHANGE IF YOU ARE USING THE A70/77.** It is almost certain that sooner or later you will have relay problems in the CX7 if you don't. The modification is as follows: Insert a resistor (approximately 100 ohms @ 1 watt) in series with the relay contacts inside the CX7. Add a bit of decoupling for RF on the side of the relay line AWAY from the relay itself (at the chassis jack location) by using a small molded choke or a couple of ferrite beads and a .001 disc to chassis. The object is to keep RF OUT of the CX7! The important point is to make sure there are NO capacitors directly across the reed relay contacts unless the 100 ohm resistor is in series with them. See diagram below:

A-76 MEASURES 12544. SO USE 2 W. RESISTOR

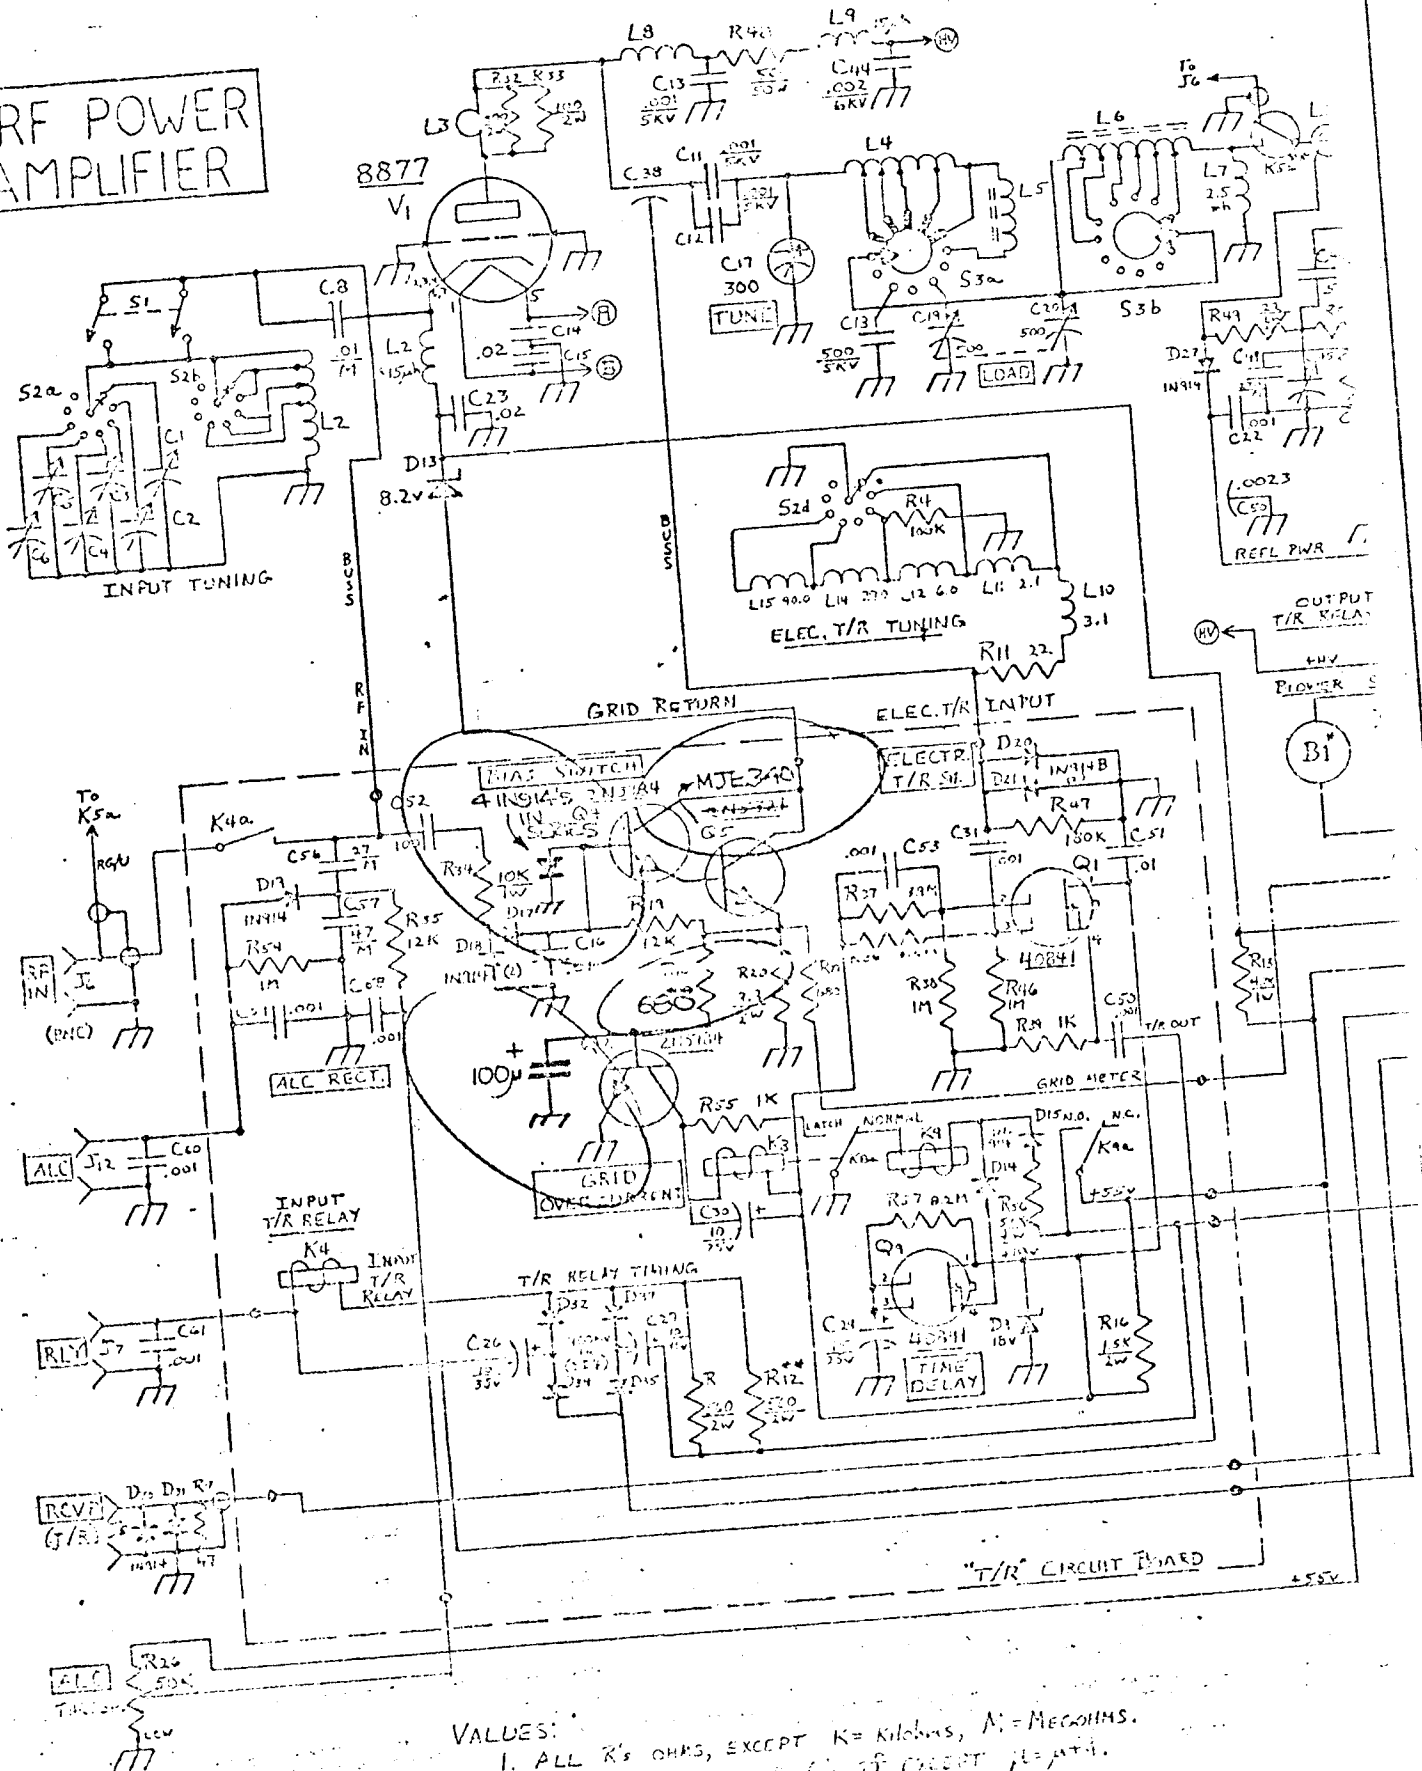
RF POWER AMPLIFIER

For all A70/A77 units: The HV feedthrough tip jack located at the top, front of the partition between power supply and rf compartments is rated at 11KV by its manufacturer but may fail catastrophically, taking with it the bias switch semiconductors (Q4,5, D17,18) and quite possibly the HV rectifier (D5-8) and/or the plate overcurrent relay shunt R42!! Avoid this by pulling out the jack, installing a rubber grommet in the 1/4-inch hole, and run a piece of the original HV red lead wire through, soldering it on both ends.

NOTE: See attached schematic for changes discussed above.
