S/1 NEWS

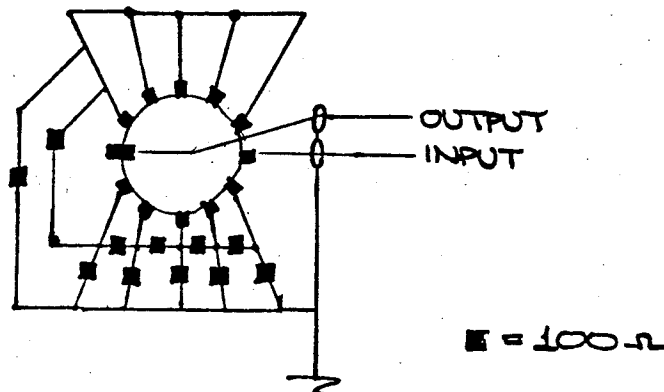
5. A receive attenuator may be constructed using a Mallory 3226J switch and 1/4-watt/100-ohm resistors in the following manner. This will give 10db steps up to 50db max. Install the switch in place of the FSK control. Use miniature coax for connections.

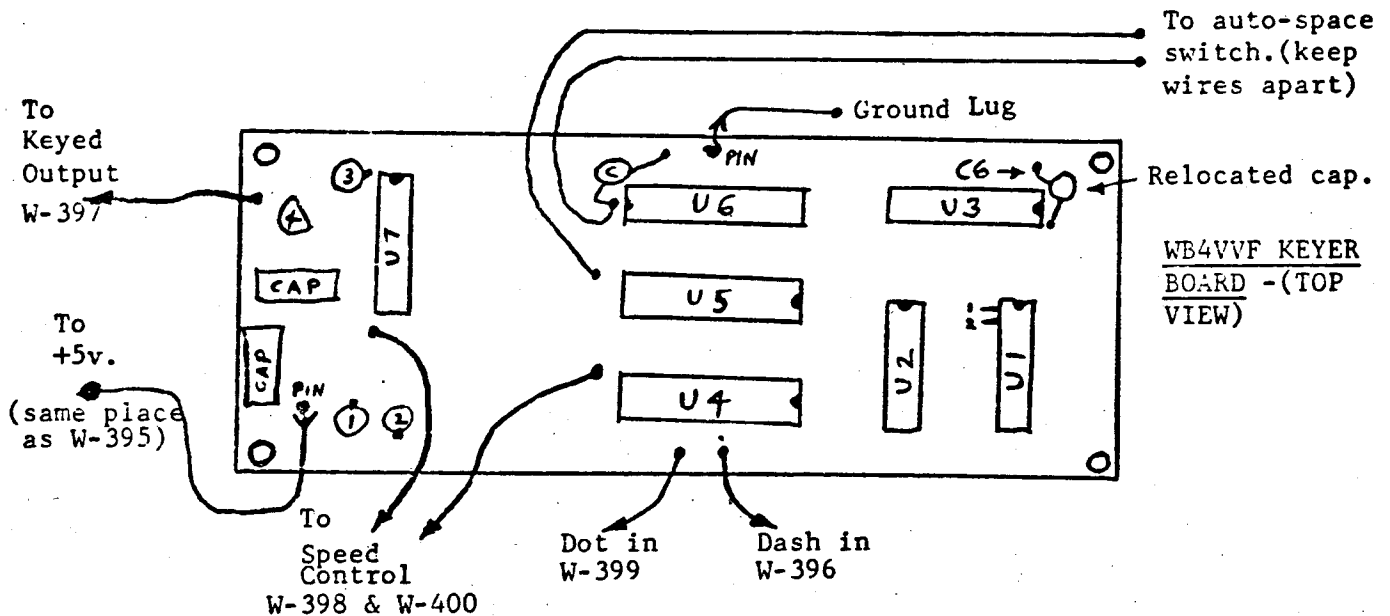
14. Operation of CX-7 Mode switch between CW1 & USB will cause keyer to send a Dash due to induced voltage in the common wiring harness. Replace wires #162 & #163 with shielded pair between rear terminals of counter cage and the keyer jack. Ground shield at the jack end only. The .01 uF jack bypass caps may be .005 uF. Route shielded pair over top side of chassis to hole near keyer jack.

15. To remove the Dash memory feature of the keyer, cut foil to pin #2 of I.C. U-1 or if in a socket, bend pin #2 out to one side and re-insert the I.C. This will not effect any other operation of the keyer.
16. The auto-space switch may be operated with a small screwdriver thru a vent hole in the cabinet. Note that the auto-space feature is active when the switch is OPEN.
