S/1 NEWS

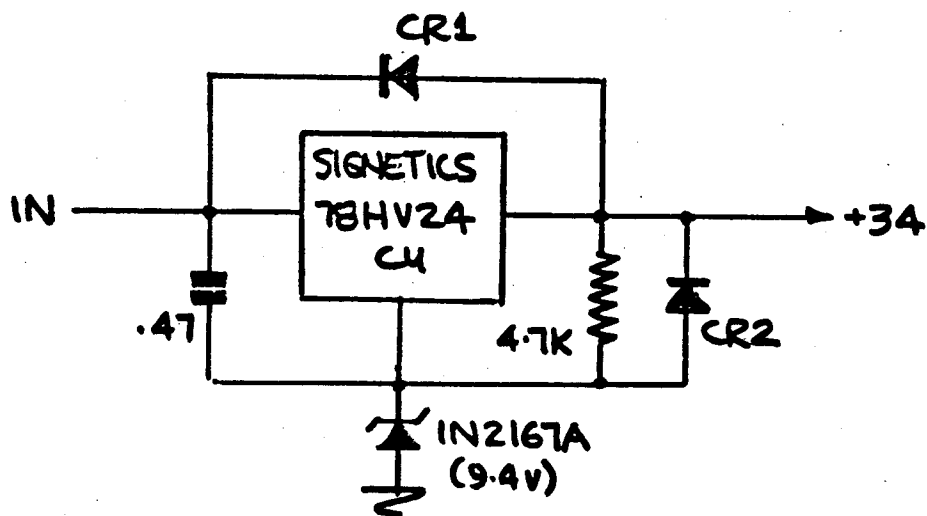
IC Regulator +34 Volts

The following regulator circuit is from W2GRU and will provide the required +34 volts for the CX7 thereby eliminating additional discrete components on the power supply board. According to John, the Signetics 78HV24CU can withstand 60 volts across the input-output, unlike the LM-317, and will not short like the 317 may since it is only rated for 40 volts input-output. Be sure to include the diodes as shown. CR1 prevents any output capacitor discharge from going through the IC if the input falls faster than the output. CR2 prevents any high current discharges through the low current circuitry in case of an output short. Repeated output shorts will not damage this regulator. See schematic below:

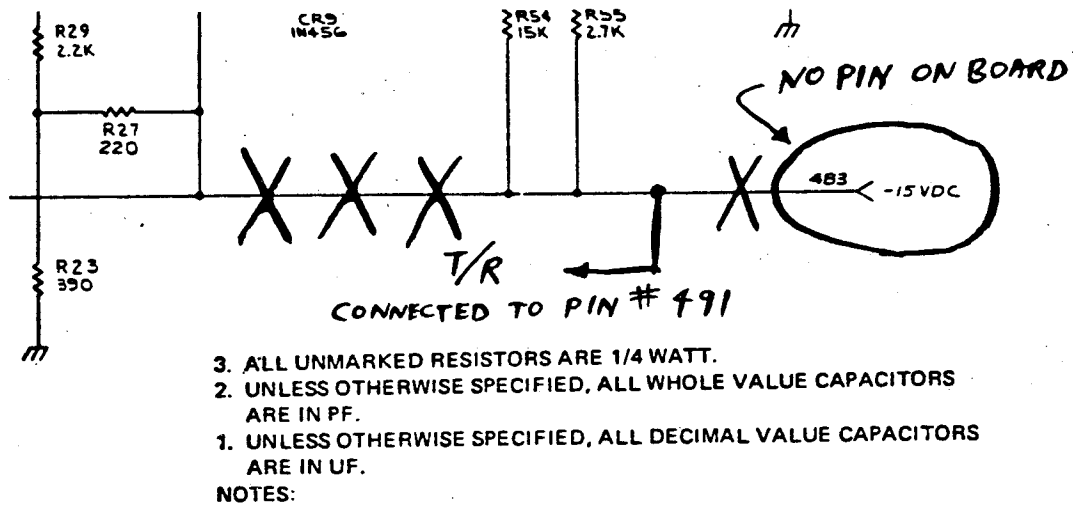
Figure 6-10. AGC Detector Board A9 Schematic Diagram

Paul, W8CKX, notes an error that is in both the original and Thomas manuals. The error is due to a late production change on the AGC Detector board, A9. See schematic below which notes the error:
