MODIFICATIONS AND REPAIR INFORMATION

APRIL-75

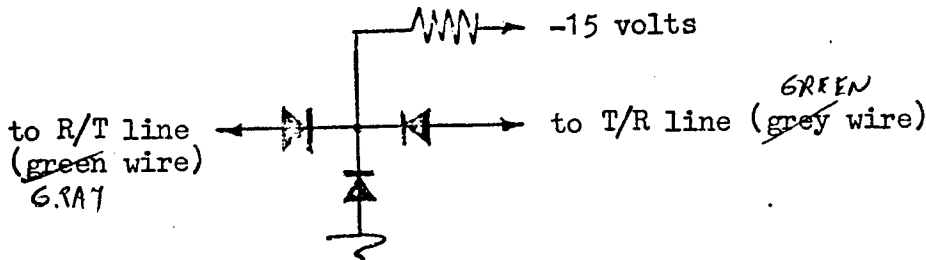
The following suggestion is from Dick, KØHHP. The network below will cure frequency shift when switching from one transmit VFO to another: Diodes are 1N4001 or equivalent and the resistor is 220-ohm/2-watt.
