VOL. I
NO'S 7-12
ORIGINALS

JULY-75

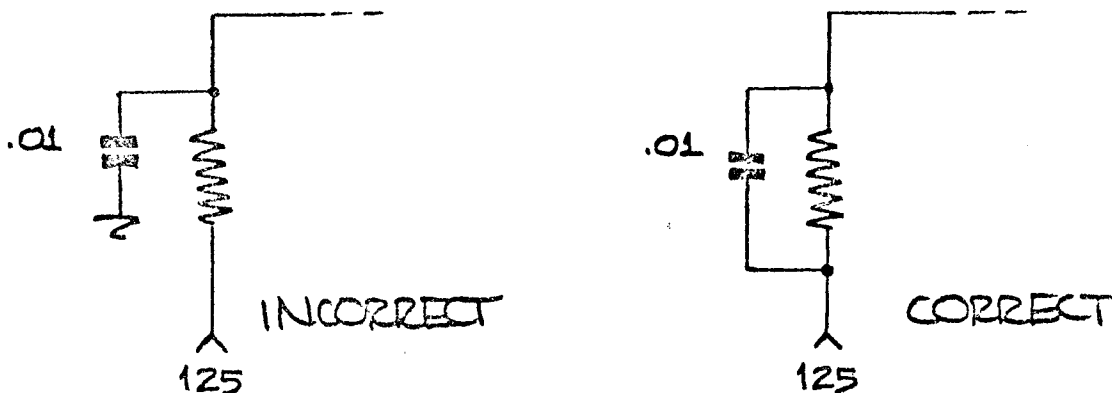
On "B" power supply boards using the Motorola Audio IC, there is an error on the board which effects high frequency response. At pin 125 (audio in) on power supply board immediately after a resistor there is a .01µf capacitor to ground. This capacitor should not return to ground but should be in parallel with the resistor. See drawings below:

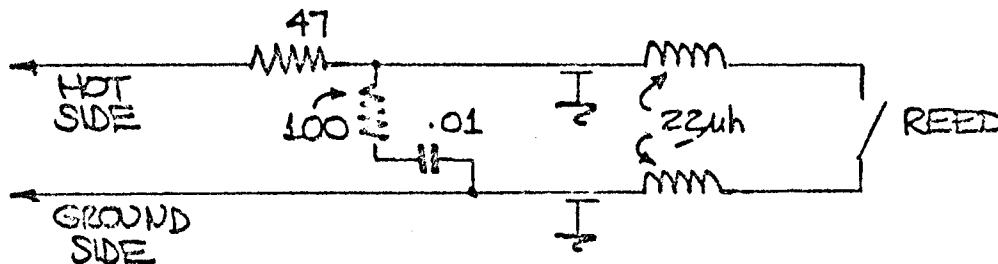
According to K2GI, Signal/One suggested the following circuit to prevent welding contacts together on the reed relay that are used for keying a linear amplifier
