VOL. I
NO'S 7-12
ORIGINALS

MODIFICATIONS AND REPAIR INFORMATION

JULY-75

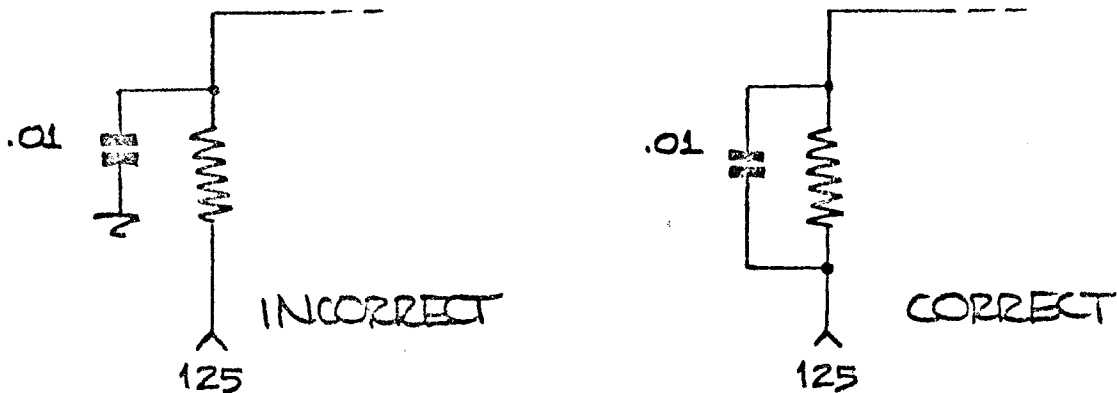
On "B" power supply boards using the Motorola Audio IC, there is an error on the board which effects high frequency response. At pin 125 (audio in) on power supply board immediately after a resistor there is a .01uf capacitor to ground. This capacitor should not return to ground but should be in parallel with the resistor. See drawings below:

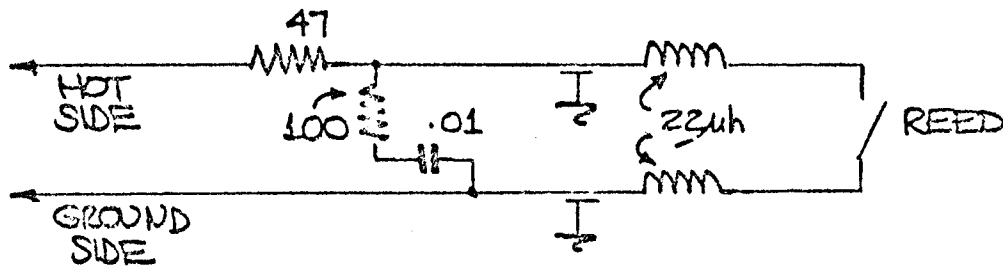
According to K2GI, Signal/One suggested the following circuit to prevent welding contacts together on the reed relay that are used for keying a linear amplifier
