# S/1 NEWS

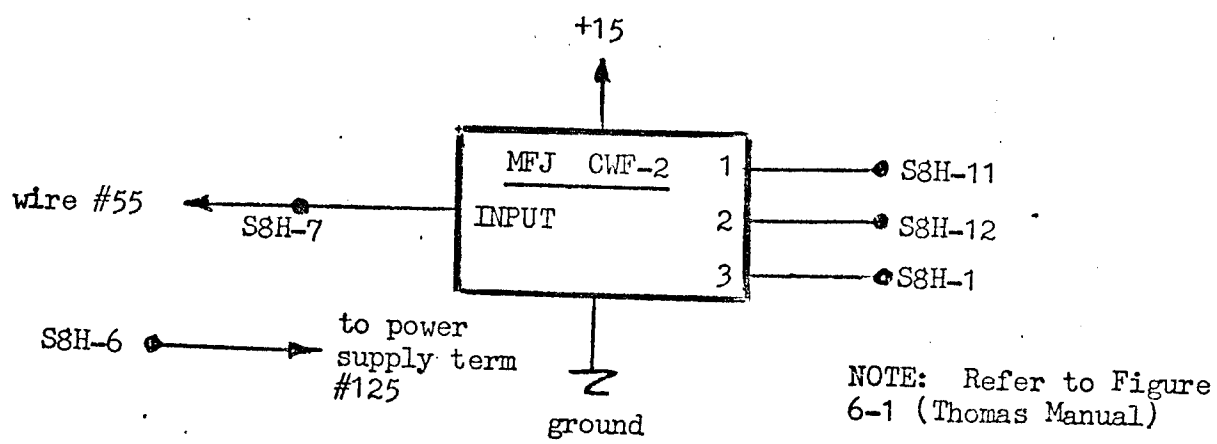
As promised in an earlier issue of S/1 NEWS (Number 7), a modification will now be described (courtesy Dick Cunningham, KØHHP) concerning the installation of a MFJ model CWF-2 filter into the CX7. This unit does a great job on CW and has bandwidths of 70, 110, and 180 Hertz. I purchased one of these little units and compared it against my installed Signal/One CW filter - in my opinion the MFJ does a much better job. Even at the narrow bandwidths there is no ringing. The modification to be described places the MFJ unit inside the CX7 near the mode switch and rewires the mode switch such that CW2, CW3, and FSK positions provide bandwidths of 180, 110, 70 hz respectively. The installed 2.1 hz filter is used for AM, LSB, USB, and CW1. WITH THIS MODIFICATION NO AUXILIARY FILTERS CAN BE USED.

The revised circuit will look like so:

1. Remove Wire #355 from S8H-7.
2. Remove Wire #185 from S8H-6.
3. Solder Wire #355 to Wire #185 and properly insulate the splice.
4. Install a jumper from S8G-6 to S8G-7. (Wire #184 is connected to S8G-6 and Wire #353 is connected to S8G-7).

5. Mount the MFJ filter in a convenient location near the mode switch.
6. Connect the MFJ filter + to any point in the +15 volt line.
7. Connect the MFJ ground to any ground location.

8. Remove coax #35 (audio input to terminal #125 on power supply board) and connect to S8H-7. Coax #35 will not reach this switch terminal and therefore will have to be extended. Shielded wire is not required for this extension. Hookup wire will do.

9. Connect MFJ filter input to S8H-7 (same terminal as in step 8).
10. Connect a new wire from S8H-6 to terminal #125 on power supply board.
11. Connect MFJ filter output #1 to S8H-11 (180 hertz output).

12. Connect MFJ filter output #2 to S8H-12 (110 hertz output).
13. Connect MFJ filter output #3 to S8H-1 (70 hertz output).
14. Clip jumper from S8H-12 to S8H-1.

NOTE: The jumpers between S8H-7, 8, 9, 10 should be left in place.
