# S/1 NEWS

VOLUME III 1977  
Number 7 JULY

SPURIOUS SIGNALS IN THE CX7

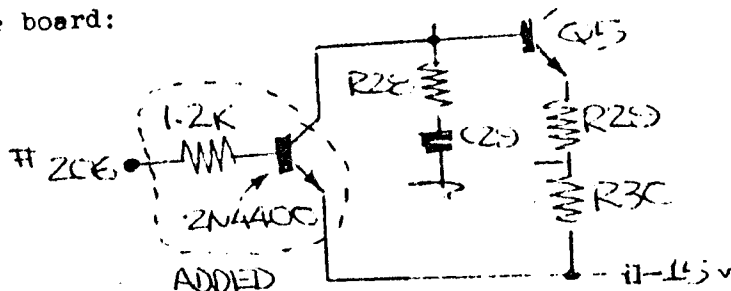
My radio transmitted three signals, at A, A\* and A+2\*, where \* is the transmit offset. Varying various oscillators showed me that the spur at A derives from the normal 34.2 Mhz signal, while the spur at A+2\* derives from (2 x normal - offset) signals. Suppressing the normal 34.2 Mhz signal in transmit mode when A/TO is selected eliminates both spurs.

The normal 34.2 Mhz signal is generated on the BFO board, A4, by mixing the reference oscillator at 43.1 Mhz and the BFO at 8.9 Mhz, in IC2. This mixer is connected to the R/T line in A/TO mode, to turn it off in transmit. Unfortunately, it still acts like a mixer (with very low conversion gain). Disconnecting the coax between mixer output (pins 224 & 225) and IF board has no effect on the spurs; the undesired IC2 products must be riding out on the offset 34.2 Mhz signal, through stray coupling as suggested by Mark, K6BE.

The 43.1 Mhz oscillator drives only the normal 34.2 Mhz mixer (the whole complex scheme is necessary to implement IF shift). If the mixer is turned off, why not turn off the oscillator too? This completely suppresses the spurious signals. I tacked the following modification on the top side of A4, to avoid removing the board:

There's nothing magic about the components - they happened to be handy. The 2N4400 is a general purpose 40v Silicon switch."

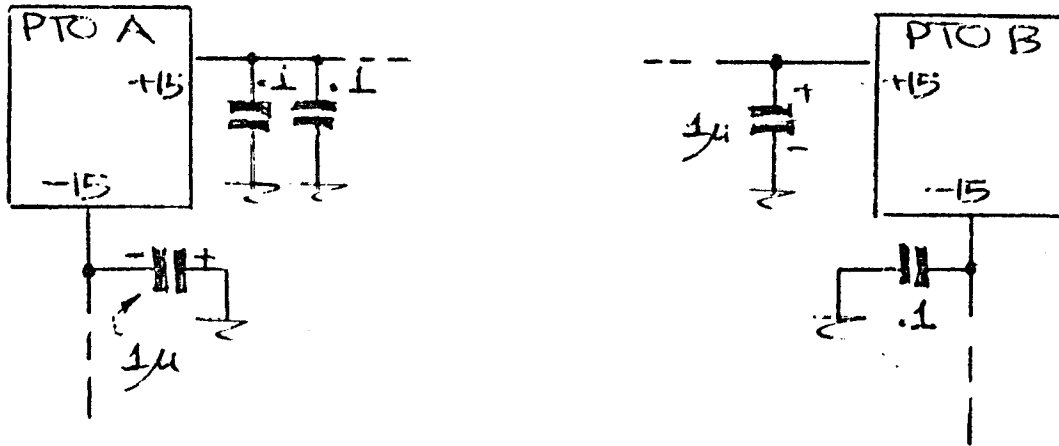
1. Careful analysis with a spectrum analyzer/tracking generator combination (not exactly equipment available to everyone!) shows up a lot of spurs in the CX7. Most are 34.40 db down from the main signal but they all can be heard. The worst ones are in-band spurs on 80 meters that are +100 Khz from the desired signal. These can be reduced down to 60 db below the desired signal by bypassing the +15 and -15 volt pins AT EACH OF THE PTO ASSEMBLIES as shown below:

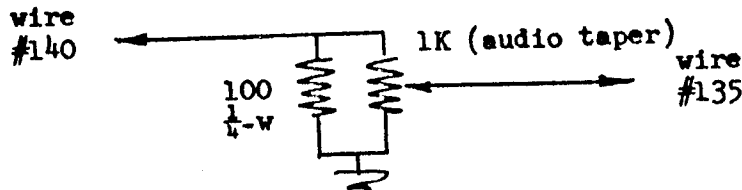
1. Q4 on Audio board, A6, can be protected by adding a 1N270 from pin 338 to ground - cathode of the diode to ground. (K6BE/5)
2. The following modification will allow complete shut-off and smooth adjustment at low levels of the SIDETONE level: (K6BE/5)

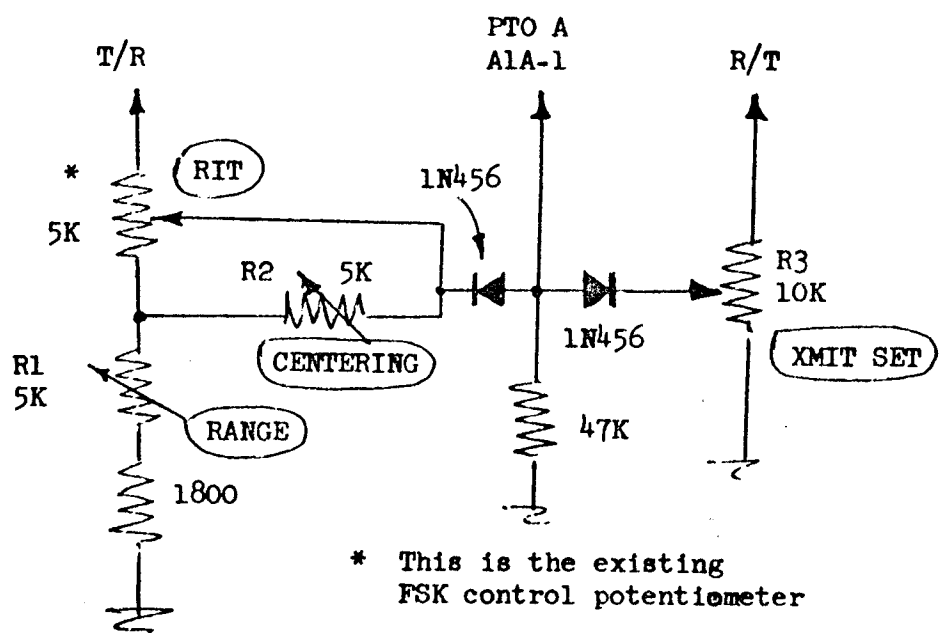
schematic on next page....

3. One of the most desirable modifications to the CX7 series is RECEIVER INCREMENTAL TUNING (RIT). S/1 NEWS has published a variety of circuits for accomplishing this but, in our estimation, the simplest and most desirable RIT modification is by K6BE/5. His RIT modification will allow approximately  $\pm 1$  Khz range (adjustable) and does not require a IN/OUT switch. No front panel modifications are required and no active components are used. The existing FSK potentiometer is utilized as the RIT adjust potentiometer. See schematic below. R1 and R2 are Bourns 338F-1-502 and R3 is Bourns 338F-1-103. The modification as shown is new but a similar version was published in S/1 NEWS, Volume II, Number 7. The one presented here is easier to setup.

Adjust R1 for the RIT range desired at the low end of the PTO range. Range of RIT is slightly greater at upper end of PTO range.

Adjust R2 so that the PTO frequency at center of RIT control range is midway between frequencies at ends of RIT control.

Adjust R3 so that the PTO frequency does not change when the transmitter is keyed. This adjustment is made with the RIT control at the center of its range.
