MAY-75

MODIFICATIONS AND REPAIR INFORMATION

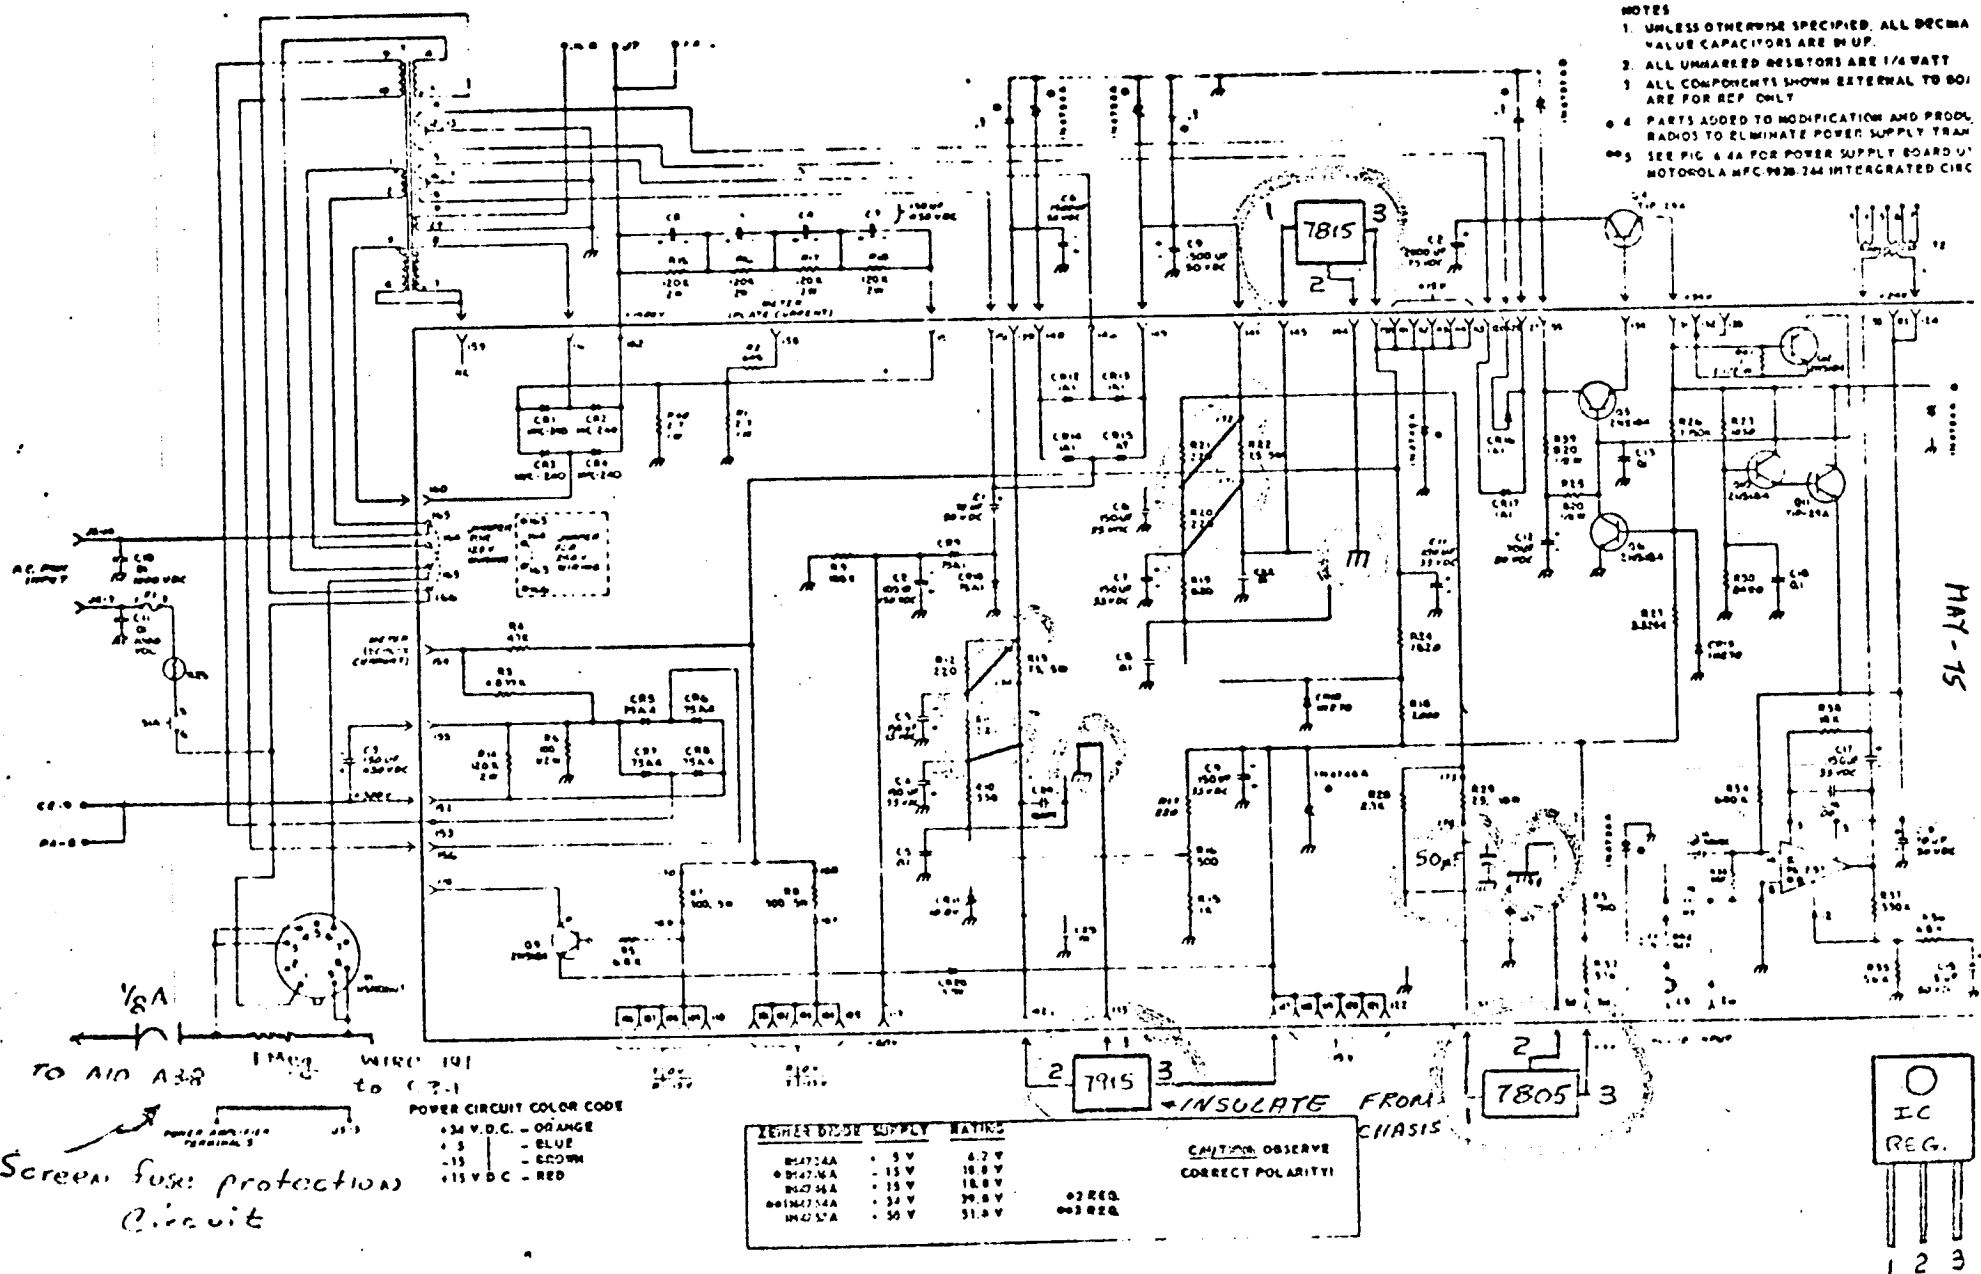
TO AID A38
 Screen fuse protection circuit

IC	VOLTS	REG.
7815	+5V	REG.
7915	-15V	REG.
7805	+5V	REG.
